## PROJECT PROFILE

# St. Louis Interstate Bridge

### Surface Repairs Completed without Interrupting Major League Baseball

**Job:** St. Louis Interstate Bridge  
**Where:** St. Louis, Missouri  
**When:** 2004  
**Size:** 170 Cubic Yards  
**Owner:** Missouri Department of Transportation  
**Engineer:** Bridge Maintenance, St. Louis District  
**Concrete Contractor:** Millstone Bangert  
**Concrete Supplier:** Modified Concrete  
**Product Used:** Rapid Set® Latex Modified Concrete

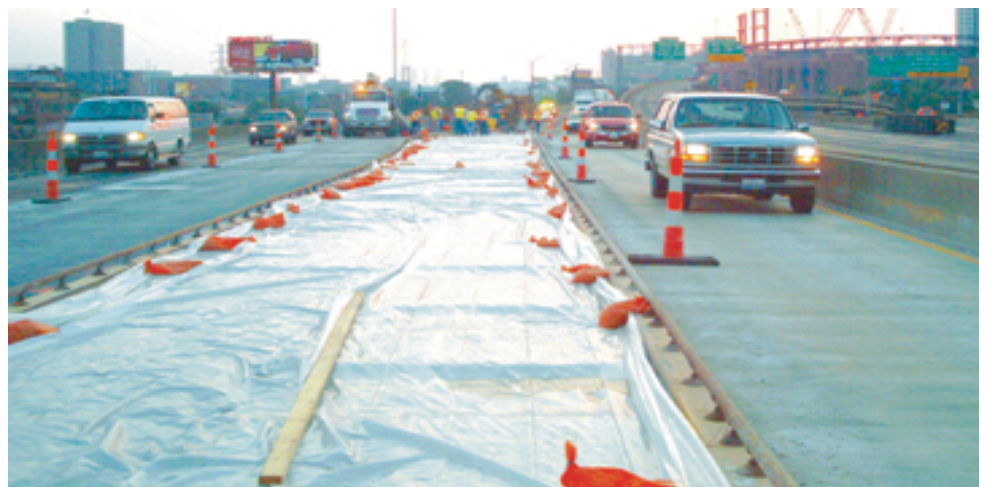
concrete bridges in this region have been covered with asphalt or an epoxy overlay in the past. The chlorides in the concrete have accelerated the deterioration of the concrete. The typical depth of bad concrete is 1-1/2" to 3". To repair this, removal to the upper rebar mat is standard with deeper areas or full depth expected.

Millstone Bangert, the General Contractor was awarded the job with the stipulation that work was not to be conducted on baseball weekends. Modified Concrete, an Indiana specialty concrete producer produced the RSLMC. Hydro-demolition was used for the surface removal, providing an excellent surface for adhesion. Closure time was from 8:00 p.m. Friday to 12:00 p.m. Sunday. Preparation time for the surface took more than 12 hours per lane.

Air content was kept below 2.5% and slump was 9" at discharge. Finishing

consisted of hand work along the edges, bull floating and a tine finish. Burlap was placed directly behind the tine, about 12 to 15 minutes behind the Bidwell finisher. Fogging of the fresh RSLMC and burlap was continuous. Visqueen was placed over the burlap and watered down to prevent it from blowing up off the deck.
